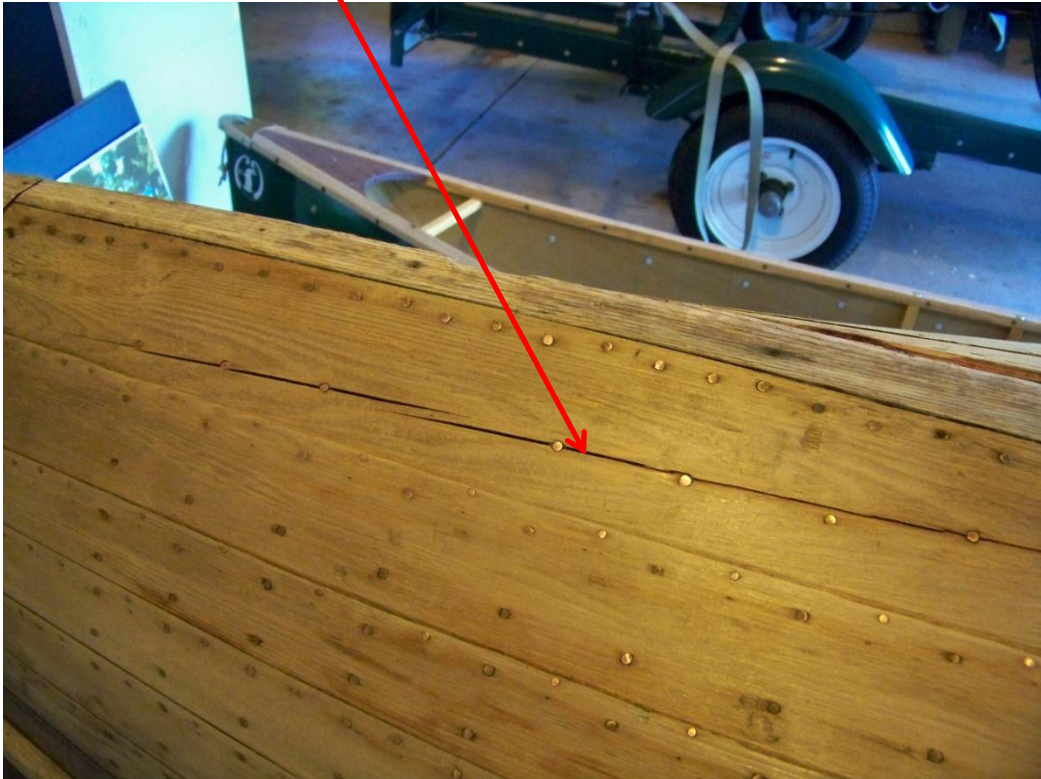
Cracks in garboard at stem area
